Manhole Inspection Summary

Manhole # S17EE2012MH

Insp Date: **8/3/06 9:00 AM**

Location Address: **1900 SULGRAVE AVE**

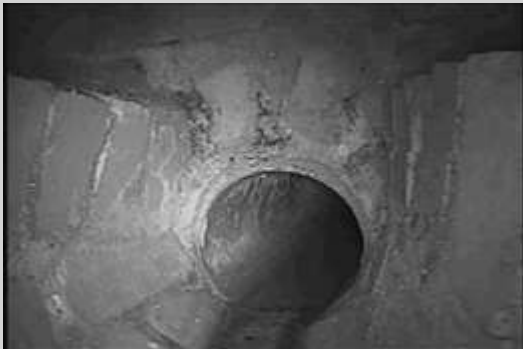
6 in. Circular Gravity Sewer
Pipe In @ 9 O'Clock

Pipe Material: **Clay** ☐ Pipe Lined

Infiltration: **None** Pipe Seal Cond: **Unknown**
